The Art of Matching Anterior Porcelain Restorations: A Clinical Case Report

Emil Hawary, DDS, FAACD, FAGD, DICOI

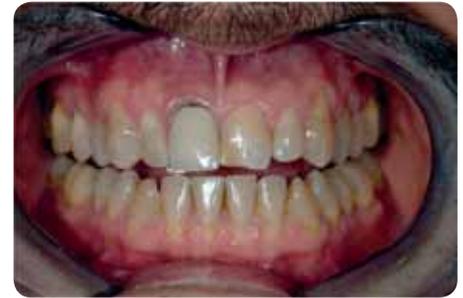
FIGURE 2. Preoperative retracted frontal view showing an opaque monochromatic PFM on No. 8 and discolored large composite on No. 9.

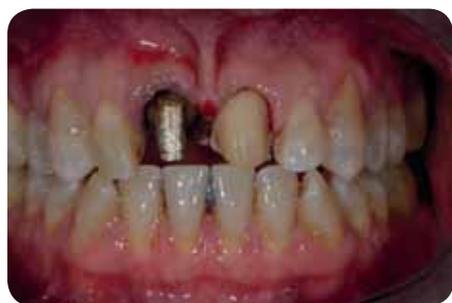
FIGURE 5. The old PFM crown was removed revealing the discolored root and dark tissue margin. Preparation of No. 9 extended 0.5 mm subgingivally on the facial and the gingival proximal area extended lingually at the crest of the papilla.

The post space was prepared using Peeso reamers (Premier Dental Products, Plymouth Meeting, Pa.). Preparation of the left central incisor was guided by reduction templates (pinhole preparation guide, Shofu Dental, San Marcus, Calif.). The preparation was extended 0.5 mm subgingivally with a 1 mm chamfer margin on the facial, and the lingual margins were placed at the incisal marginal ridge for maximum strength of the tooth and the restoration. Lingual margins should not be placed in the lingual fossa, which is the area with the highest concentration of stress on the entire tooth.^{15,16} The tooth was prepared in such a manner as to give the laboratory 2 mm of incisal and 1.5 mm of facial room to develop subtle internal characterization with the porcelain. The gingival proximal area extended lingually at the crest of the papilla to provide adequate porcelain to eliminate black triangles (**FIGURE 5**).

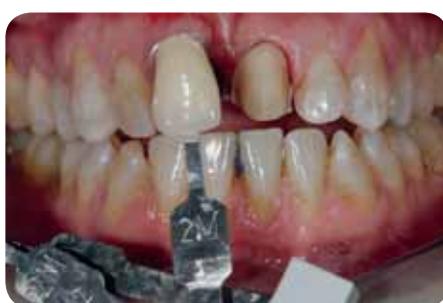
FIGURE 6. Stump shades were chosen with the stump guide in view for laboratory use.

Polishing of the preparations was completed with rubber cups and ceramiste points (Shofu Dental). A small amount of gingival contouring was also done with electrosurge (Parkell Inc., Farmingdale, N.Y.) prior to taking the final impression. Stump shades were chosen and photographs were taken of the preparations with the stump guide in view for laboratory use (FIGURE 6).

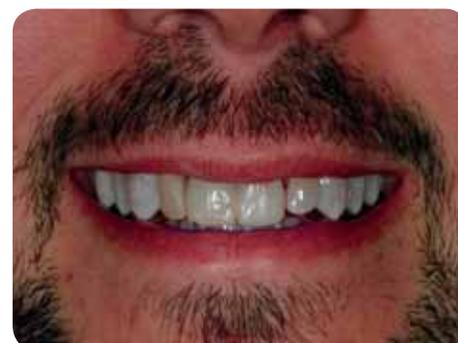
FIGURE 7. Full-smile view showing the temporaries to guide the laboratory for the length and form of the final restorations.

the length of the final restorations using the cast of the provisional as a guide to improve the smile line and provide a more pleasing smile (FIGURE 7).

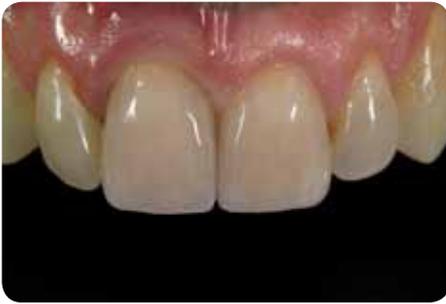
FIGURE 8. Try-in of the zirconia crown on tooth No. 8 showed that it was higher in value. Custom staining was done to match the rest of the teeth.

After the restorations were completed, they were tried in (FIGURE 8) and were evaluated for marginal fit, contours and color. Some shade-matching challenges were anticipated because of the pure opaque white nature of the zirconia post and the pressed ceramic core. When dissimilar restorative materials are used, it is important to establish similar values before any addition of chroma is made. Excellent communication with the laboratory, with a mutual understanding of both clinical and technical challenges, will facilitate excellent treatment outcome.

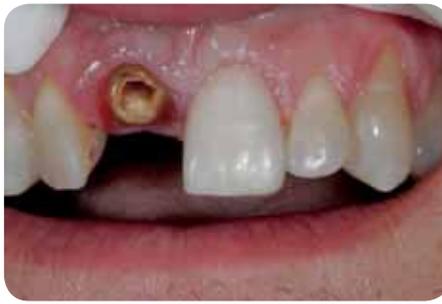
FIGURE 9. The porcelain veneer was bonded to No. 9. Temporary restoration was removed from No. 8 to try in the zirconia post with pressed ceramic core. Note insufficient remaining tooth structure indicating guarded prognosis; however, adequate ferrule was present all around.

and when ready, a coat of prime and bond NT was applied to the inner surface. RelyX luting cement Tr shade (3M ESPE) was used to bond the tooth. The restoration was then cured with 501 optilux light (Kerr) for 3 seconds. Excess cement was removed and DeOx glycerin gel (Ultradent) was applied to the margin to avoid an oxygen-inhibited layer. Then the tooth was light cured for an additional 40 seconds on the facial and the lingual. Excess cement was carefully removed using a Bard Parker scalpel No.12 (Aspen Medical, Caledonia, Mich.). The margins were polished with Enamelize diamond polishing paste (Cosmedent) and prophyl cup (FIGURE 9). The occlusion was evaluated to ensure light centric contact and even contact on excursions.

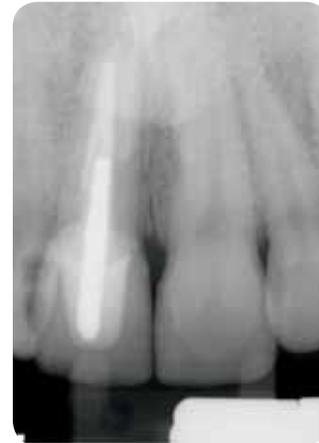
FIGURE 10. Postoperative radiograph showing zirconia post and porcelain jacket crown on the right central incisor.

It was cemented using RelyX Unicem resin cement. Excess cement was removed and the margins were polished with Enamelize and prophyl cup (FIGURE 10).
